Global Journal of Civil and Environmental Engineering

Geotechnical Perspective of the Causes of Cracks in Building of University Campus (Sindh University Jamshoro Sindh Pakistan)

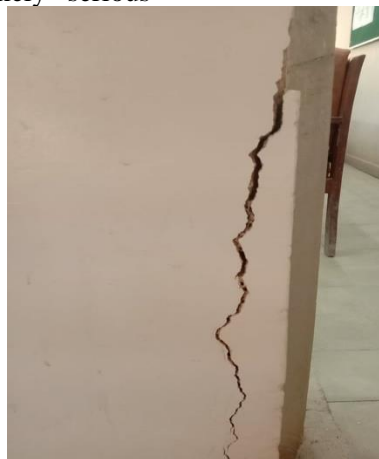
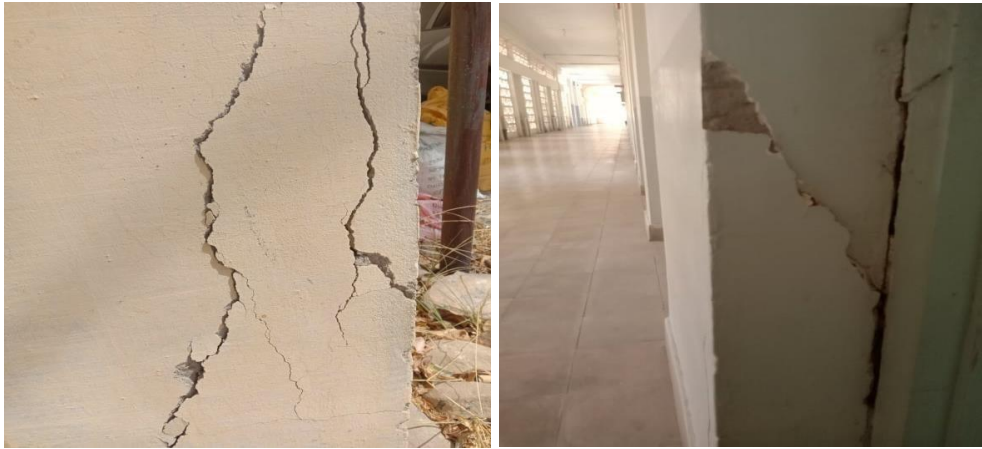
As the second phase of the structure review was done by estimating the width, length and direction of the breaks. In this way, beginning toward the start of the investigation the length and width of the cracks were checked and observing exercises were proceeded every hour and then to see whether these two boundaries increments with a hole of time or not. The checking cycle of the cracks demonstrated that the cracks in the structure are dynamic cracks appeared by the presence of new crack edges during the structure review. Major share of these cracks are named extremely serious

classified as strength cracks with a normal width more prominent than 20mm [8] in the establishment dividers and more noteworthy than the predetermined 0.3mm on the segments, radiates and the flight of stairs section. This is exceptionally disturbing when contrasted and the most extreme worthy worth given by Burland and Day (1977) and in BS8110 (1997). These cracks are more ghastly on the left hand side of the structure which has more stacking contrasted with the correct hand side of the structure, same as on the ground floor of the structure than on its first floor. These cracks are fast expanding inside and out and width brought about by the settlement of the establishment soil and the conceivable sliding of certain parts of the building /establishment [4]. The flat cracks are wide and of consistent width all through their lengths and appear to have happened simultaneously perhaps brought about by inordinate settlement because of inadequately built establishment and helpless workmanship. Slanting breaks have likewise risen up out of the sides of pillars pocket, entryway and windows edges, and the vertical ones were distinguished. They might be brought about by the progressive vertical development of the establishment and solid shrinkage. The chunk and a portion of the sections additionally endure extreme cracks reaching out through the dividers perhaps brought about by; lopsided settlement in the establishment soil putting the structure under pressure. Figure 2 shows a portion of these cracks.

Figure 2: Cracks showing size and orientations in the building.

B. The cracks are extremely serious containing dynamic and torpid, impacting the primary development of the structure, which are brought about by soil combination under the footings and the establishment dividers; differential settlement of the structure all in all and a helpless establishment plan as well as development technique.

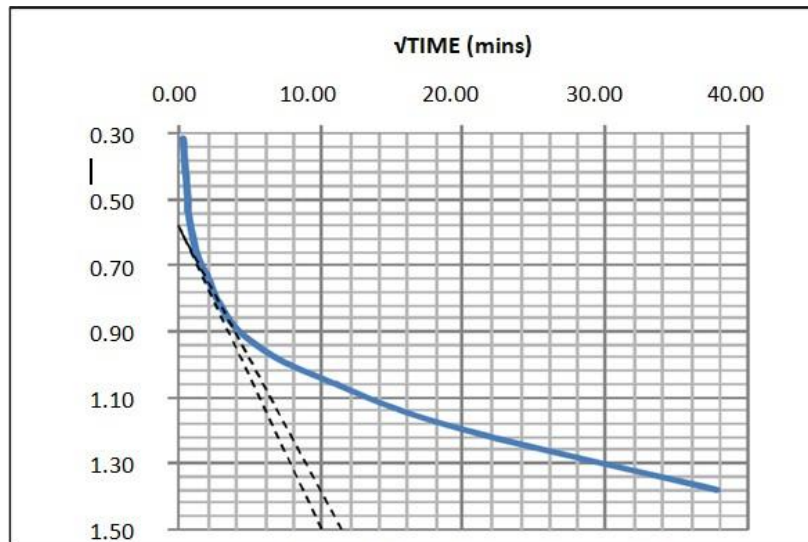
Figure 4: Typical Consolidation test result

Figure 4 shows the coefficient of combination was resolved utilizing the square base of time strategy and a regular consequence of this test. The coefficient of solidification of the soil lies between the scope of 0.23cm²/sec and 0.34cm²/sec which is viewed as moderately low. This is a sign to the poor water driven conductivity of the soil; so the soil will keep on diminishing in volume throughout a significant stretch of time after the fast settlement and

might be a few times more prominent than the quick settlement [14-16].
